# Optimizing Vehicle Loading to Improve Operational Safety at KMP. Dharma Ferry VIII

<sup>1,2,3</sup>Nautical Study Program, Makassar Maritime Polytechnic, Indonesia

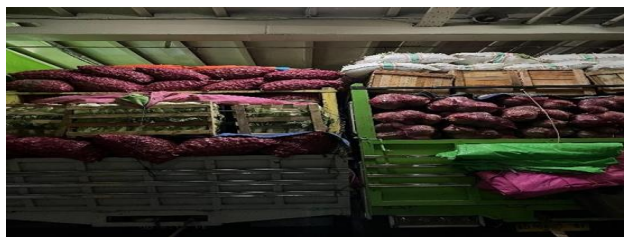
**Fig. 1. Position of the Load that is Too Close**

The first case found was the placement of vehicles too close together on the car deck, so that

the smoothing process could not be carried out optimally because the crew's movement space was limited. As a result, several vehicles have the potential to rub against each other during the voyage and access to the operational area is hampered. This condition is not in accordance with the Regulation of the Minister of Transportation Number 115 of 2016, which stipulates a minimum distance of 30 cm between vehicles and a minimum distance of 60 cm between vehicles and the ship's wall. Therefore, the arrangement of cargo that is too close together has the potential to increase the risk of shifting cargo and disrupt the safety of ship operations.

Vehicle cargo is arranged on the car deck with excessively narrow spacing between vehicles. This situation not only hinders access and movement for crew during the unloading process, but also increases the risk of collisions between vehicles, cargo damage, and jeopardizes crew safety while working.

The irregular arrangement of vehicles also hampers the crew's circulation route to the stern area and other operational areas, thereby reducing work efficiency and increasing the potential risk of accidents. In accordance with the Regulation of the Minister of Transportation Number 115 of 2016 concerning the Safety of Vehicle Transportation on Ships, every vehicle and its cargo must be arranged with adequate distance and secured using a standard lashing system to prevent shifting, friction, and endangering shipping safety.

And the distance between the front and rear of each vehicle is at least 30 cm. For vehicles whose sides are adjacent to the ship's wall, the distance is 60 cm calculated from the inner wall layer or the outer side of the hull.

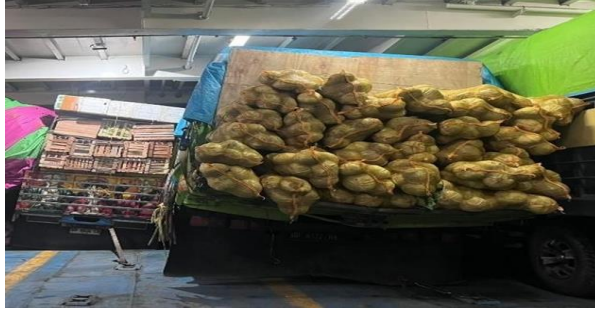
**Fig. 2 Inclined and Frictional Loads**

The second case involved a large truck (TB) that tilted during its voyage from Lembar Port to Padang Bai Port due to the lashing system being unable to support the vehicle's load optimally. This condition is inconsistent with the Minister of Transportation Regulation Number 115 of 2016, which stipulates that vehicles weighing 30–40 tons must be secured using at least four lashing gears with an appropriate safe working load (SWL) on each side of the vehicle. Furthermore, the lack of re-inspection of the lashing tightness during the voyage increases the risk of load shifting, vehicle damage, ship stability disturbances, and endangers navigational safety.

For medium to heavy-duty vehicles, the number of lashing devices used is often not commensurate with the weight and characteristics of the load. Furthermore, the lashing techniques employed are often substandard, such as using fastening angles that do not form a 45-degree angle or lashings that do not intersect. This results in suboptimal tensile and tension forces, thus rendering the load securing function ineffective.

According to IMO Resolution MSC. 479(102) (2020), to ensure optimal and safe transmission of the binding force, binding must only be performed at specific binding points directly connected to the vehicle frame (chassis), not on the bumper or axle.

Vehicles with a total weight of between 3.5 (three point five) tons and 20 (twenty) tons must use at least 2 (two) lashing gears with a suitable safe working load on each side of the vehicle.

vehicles whose total weight is between 20 (twenty) tons to 30 (thirty) tons must use at least 3 (three) lashing gears with appropriate safe working loads on each side of the vehicle;

vehicles whose total weight is between 30 (thirty) tonnes to 40 (forty) tonnes must use at least 4 (four) lashing gears with appropriate safe working loads on each side of the vehicle.

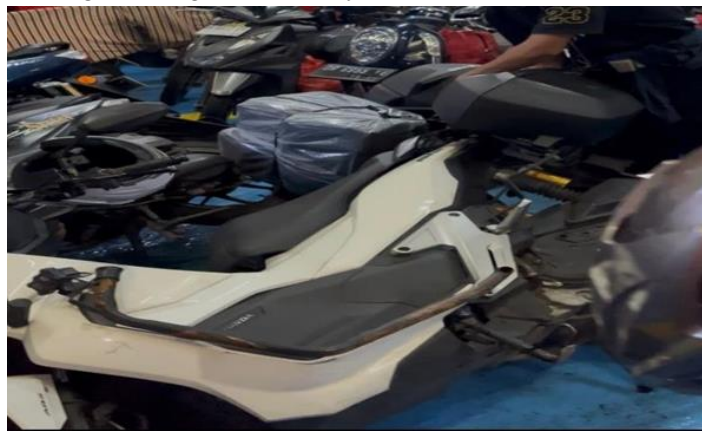
**Fig. 3 Motorcycles Fall on Cardeck**

The third case involved a motorcycle falling and hitting another vehicle during a voyage from Padangbai Port to Lembar Port during Ramadan. Observations indicated that the incident was triggered by high traffic volume, excessively tight motorcycle traffic, and inadequate safety measures. These conditions caused the motorcycle to lose balance, causing damage to surrounding vehicles, such as cracked hulls and broken brake handles, and increasing the risk to ship operational safety.

The lashing of light vehicles, particularly motorcycles, is often not carried out according to regulations. In some cases, motorcycles are not tied down at all, assuming they are relatively light.

This practice has the potential to cause cargo shifting, especially when the ship is undergoing significant maneuvering, which can endanger other cargo and the stability of the ship.

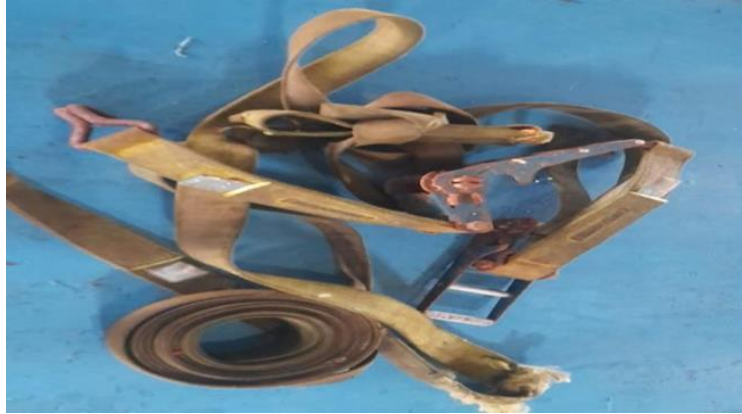
**Fig. 4 Ratchet Strap Assembly**

The fourth case involved the discovery of several lashing devices that were unsuitable for use, such as worn, rusted, and jammed ratchets. Observations revealed that these conditions reduced the effectiveness of the lashing, made the cargo lashing process difficult, and increased the risk of vehicle shifting during shipping. These findings indicate that maintenance and regular inspections of the lashing devices are still suboptimal, potentially compromising the safety of cargo on the car deck.

Observations indicate that some lashing equipment, such as ratchets, chains, and hooks, is experiencing wear, corrosion, or damage, reducing the effectiveness of cargo securing. These conditions, combined with the high volume of loading activities, mean that lashing is not always carried out according to procedures. Improved maintenance and routine inspections of equipment are needed to ensure cargo safety during shipping.

Several factors can make lashing equipment difficult to use, including rust, jammed fastening mechanisms, and wear on the wire or chain due to prolonged use without regular maintenance. Furthermore, a lack of regular inspection and maintenance can also prevent lashing equipment from being ready for use when needed, hindering the lashing process and reducing load safety.

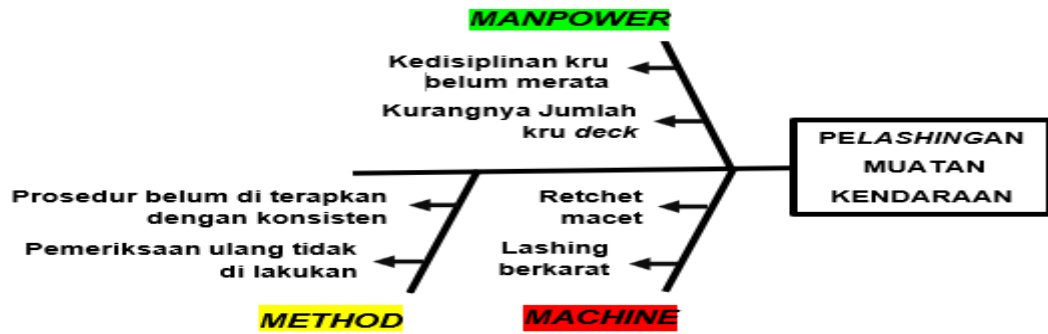
Fig. 5 Fishbone Diagram

1. Method

Lashing procedures on KMP Dharma Ferry VIII are in place and adhere to operational standards, but their implementation is inconsistent. Under heavy load conditions, space and time constraints result in suboptimal lashing installation and re-inspection, increasing the risk of cargo shifting. Therefore, oversight and discipline are required in implementing lashing procedures.

2. Machine (Lashing Equipment)

3. Manpower (Deck Crew)

Deck crew members experienced fatigue due to the additional sailing schedule and limited personnel. This reduced concentration and accuracy during the lashing operation, resulting in suboptimal cargo securing procedures. To strengthen the analysis, interview results were processed using NVivo and visualized in Project Maps to demonstrate the relationship between causal factors, the lashing operation, and its impact on operational safety on KMP Dharma Ferry VIII.
